No. 54

Aquila Airways Ltd., Short Solent flying boat, G-AKNU, crashed between Chessel and Brook on the Isle of Wight, on 15 November 1957. Report released by the Ministry of Transport and Civil Aviation (UK). CAP 149.

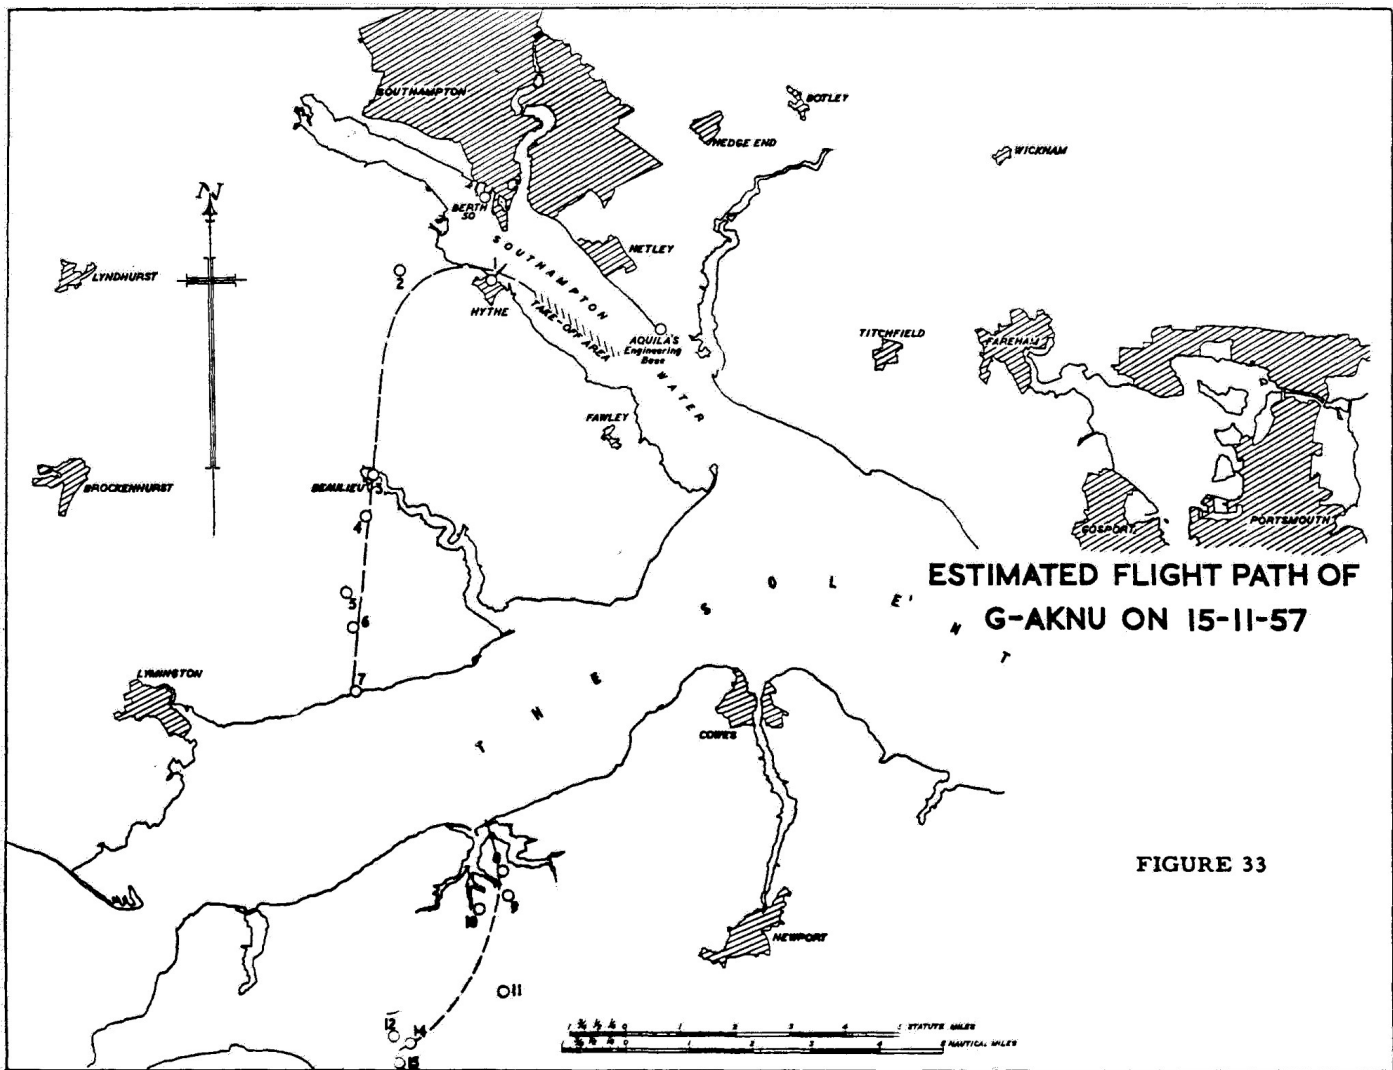
FIGURE 33

The Hampshire ground witnesses thought the aircraft was flying unusually low south of Beaulieu, but they established that up to the time when it reached the coast it was approximately on course.

The aircraft was seen to cross the Isle of Wight coast on a southerly course, but about three miles east of the point where its previous course would have taken it. Again, the witnesses spoke of it as being low.

Immediately before the crash, G-AKNU's landing lights illuminated the hill top ahead. At about the same time, the aircraft was seen to bank sharply to starboard. Until then, its course over the Isle of Wight had represented a slight but continuous starboard turn. The point of impact was approximately 300 feet above sea level.

From the above facts the following inferences were drawn: between Beaulieu and the Hampshire coast something out of the ordinary had happened, and over the Solent the aircraft made a turn to port followed by a turn to starboard. As the emergency message indicated, feathering drill had been carried out to the No. 4 (starboard outer) engine.

ESTIMATED FLIGHT PATH OF G-AKNU ON 15-11-57

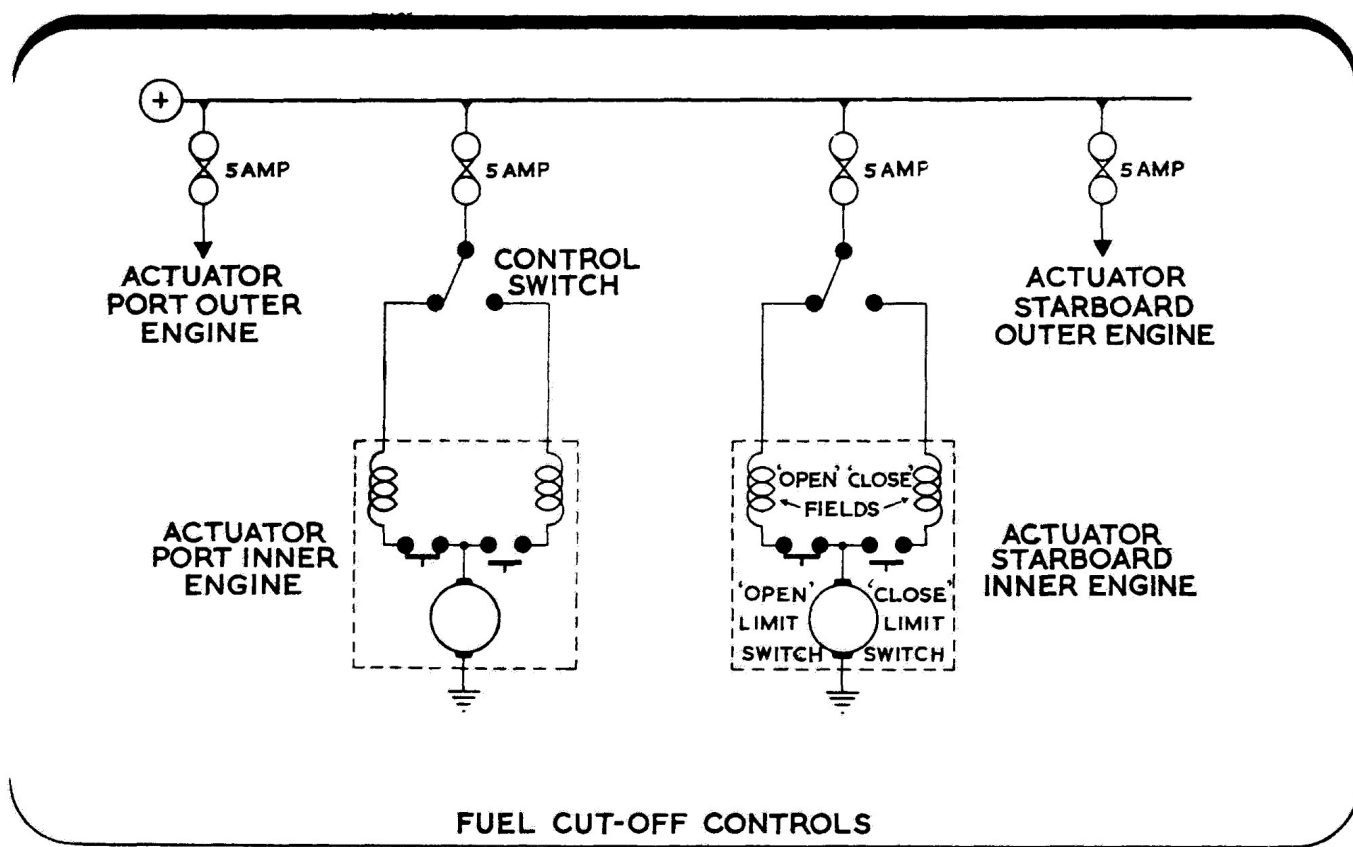
FIGURE 34 — FUEL CUT-OFF CIRCUIT DIAGRAM

In view of its importance to the Inquiry, it is necessary to describe the working of this fuel cut-off. It effects a positive interruption of the fuel supply and is mechanically operated by an actuator consisting of a screwed shaft which is driven either backwards or forwards by a split-field motor. The motor is controlled by a change-over switch on the controls roof panel. When the switch is turned from the upper or "run" position to the lower or "stop" position, electric current passes through the "stop" field and the motor moves the screwed shaft until, at the limit of travel, a limit switch interrupts the current. A diagram of the actuator circuit is given in Figure 34 and a photograph of the roof panel in Figure 35. The operation of this switch is part of the feathering drill.

Owing to their nature, it was impossible for the fuel cut-off actuators to have changed position as a result of the crash. All four actuators were found; both port ones were at the "run" position and both starboard at the "stop" position. In the case of the starboard outer engine, that position is consistent with the feathering of which the emergency message spoke, and is one of the grounds upon which it was found that the propeller had indeed been, as the message indicated, feathered. But the starboard inner propeller had not been feathered. Operating the cut-off is not performed until after the actual feathering of the propeller blades and there was no operational reason for this cut-off actuator to be in the position in which it was found. It is reasonable to infer, therefore, that this cut-off was not operated deliberately and advisedly, but preceded the engine stoppage and, in fact, caused it.

The investigation into the decisive cause of the accident is thus narrowed down to the question of what operated the actuator. It could only be so actuated by current flowing through the "stop" winding of the motor. In the circumstances of this case, that current could only have been caused to flow either by the accidental operation of the switch or by some electrical failure. Experiments conducted since the accident established that a short circuit between the two leads to the actuator would not cause it to move to the "stop" position. In fact, electrical failure could not occur unless there was, firstly, a break in the "run" lead; secondly, a breach in the insulation of the "stop" lead; and thirdly, a breach in the insulation of some other live conductor by which current passed by contact to the broken "stop" lead. The coincidence of these three separate failures is, to say the least, most unlikely.

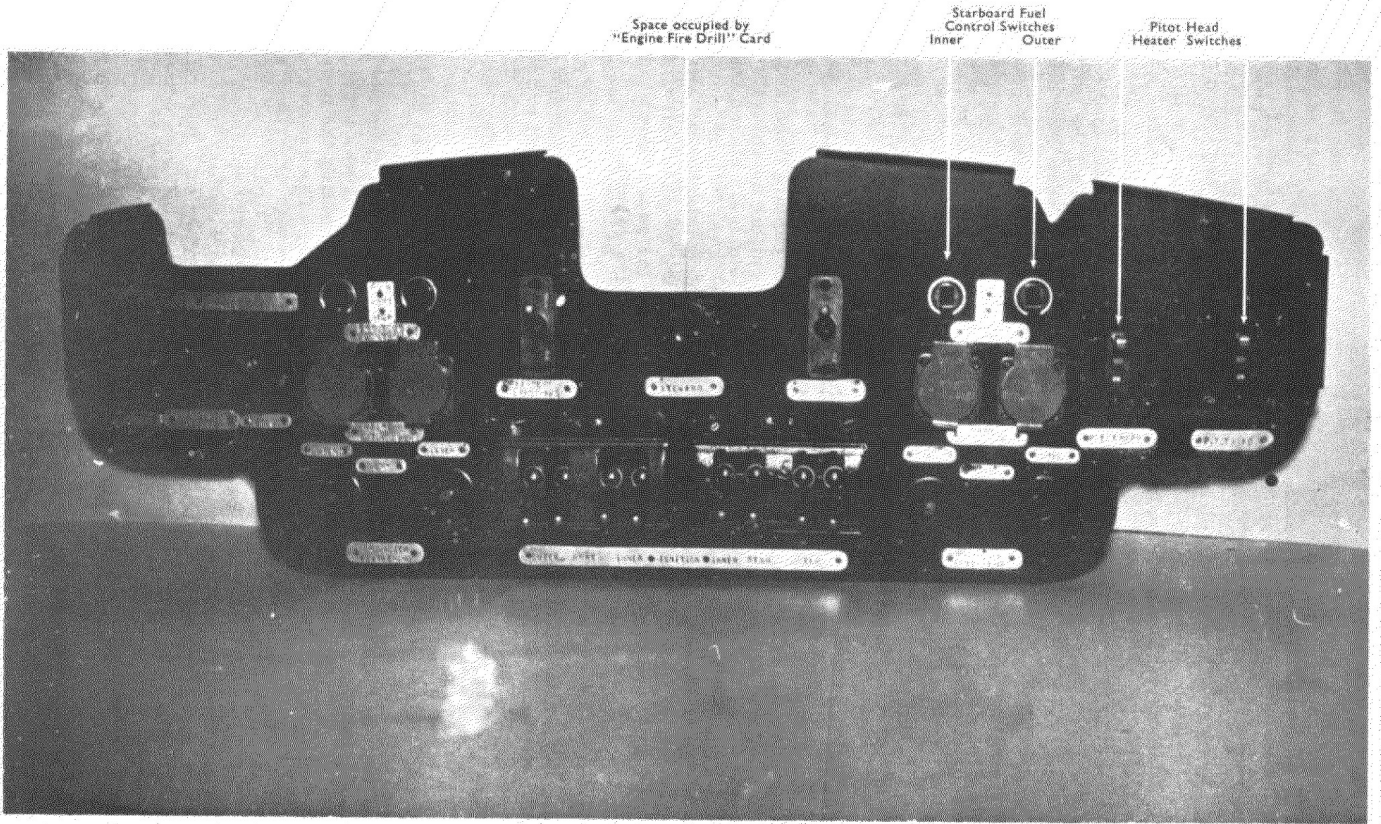
FIGURE 35

As to the accidental operation of the switch, two possibilities were considered. The first was that the captain or first officer had determined to switch on the pitot head heaters and had, in error, operated the starboard cut-off switches instead. Reference to Figure 35 shows that the two pitot head heater switches are mounted to the right of the two switches controlling the starboard fuel cut-offs; the pitot head heater switches are up when off and down when on, and the cut-off switches are up for "run" and down for "stop".

The accidental switching of the starboard inner cut-off switch when operating the adjoining starboard outer switch is difficult to visualize as having occurred. The switches were reasonably stiff and they are one and a half inches apart. With a heavily gloved hand, it might be possible to effect this accidental operation, but this was regarded as something unlikely to occur.

REPRODUCTION OF ROOF INSTRUMENT PANEL

The accidental operation of such a switch may endanger an aircraft and if not traced and rectified may lead to disaster. It is, therefore, important that steps should be taken to minimize the risk of accidental operation. On the Solent III this risk could arise from the

positioning of the starboard switches in proximity to the pitot head heater switches and from the lack of any guard to the cut-off switches. Such proximity should where possible be avoided in designing instrument panels, and where it cannot be avoided either the switches ought to be of such differing design as to make confusion with their neighbours impossible, or the switches should be effectually guarded. The Commissioner doubted whether the semi-circular metal strips fitted outside these switches on Solent III's after the captain's mishap were sufficient to eliminate the risk but was informed that since this accident Aquila have fitted the switches on their Solent III's with a shield between the two switches and a bridge over them, so that to operate them a finger has to be inserted under the bridge.
